SSC Service Bulletin

no. 81-220

MODELS AFFECTED: XLU SERIES

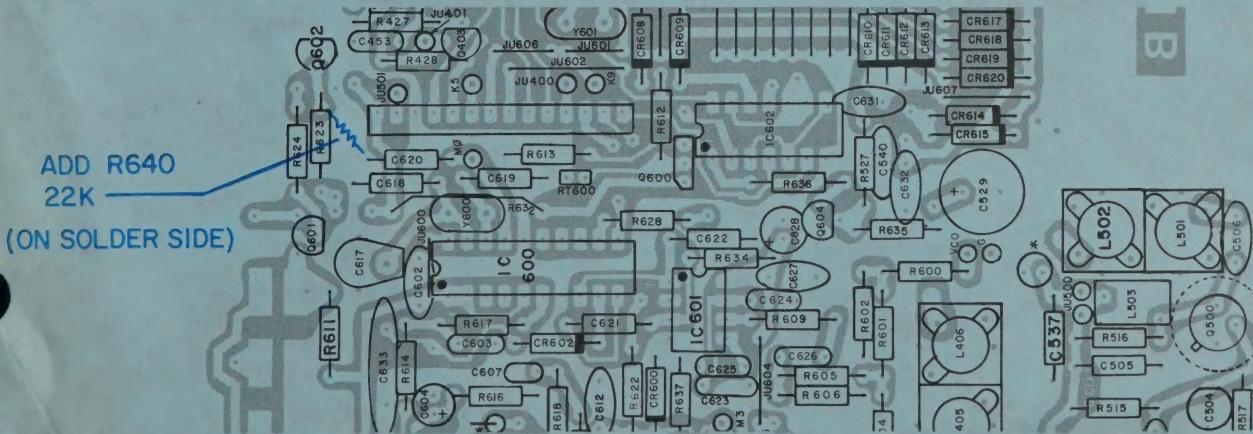
PROBLEM: WHEN INTERFACING THE MA-330 OR MA-331 WITH THE XLU SERIES RADIOS, THE AUTOMATIC PTT CIRCUIT FOR THE TOUCH PAD WILL NOT ENGAGE THE TRANSMITTER

Add a 22K ohm resistor (4704-0223-032) from the base of Q602 to ground on foil side of P.C. Board.
